RE: 2014-2015 Annual Report for United Heckathorn Superfund Site

Upland Capping System Richmond, California

2014-2015 ANNUAL REPORT FOR

UNITED HECKATHORN SUPERFUND SITE **UPLAND CAPPING SYSTEM** RICHMOND, CALIFORNIA

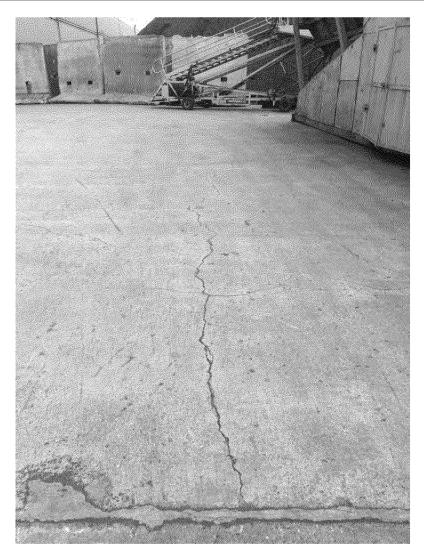
- **SW-3 Area** Minor surficial cracks were observed within and to the west of the bulk product storage area, with heavier cracks and seams located to the northwest of interceptor SW-3 at the southern end of the upland capping system (Appendix A; Photos 1, 3, 4, and 5). Cracks and concrete seams identified as high priority in the previous inspections were observed to have been patched (Appendix A; Photo 2).

Photo 1 – Looking south along western alley of secondary storage area: surficial cracking in SW-3 area, with sealed crack in foreground.

No evidence of cracks, gaps, significant cap deterioration, or other material breach with apparent potential for exposure of the underlying subgrade was observed during the inspection. Weiss recommends that LRTC continue to monitor minor cracks noted during the inspection. No repairs are recommended at this time.

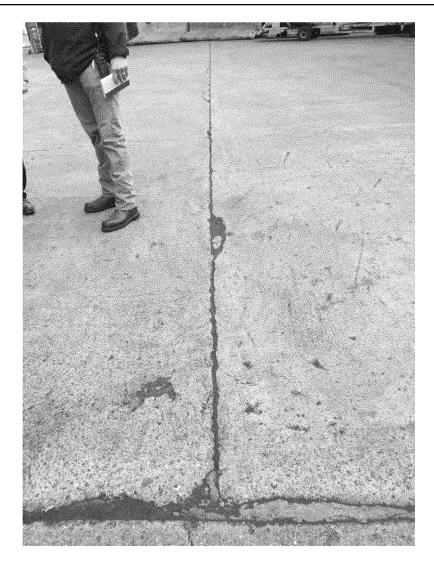
Photo 2 – Looking south along western alley of secondary storage area: sealed surficial cracks at concrete seam.

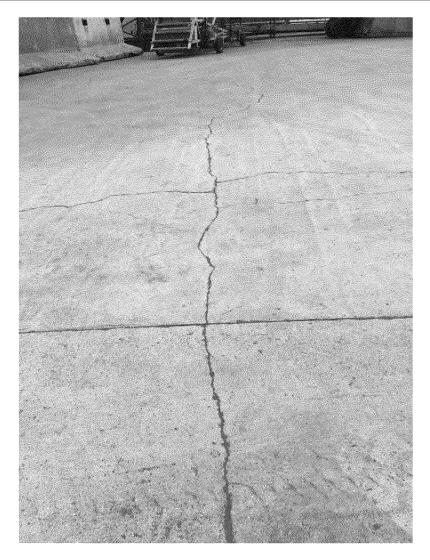
Photo 3 – Looking west across western alley of secondary storage area: surficial cracking in SW-3 area.

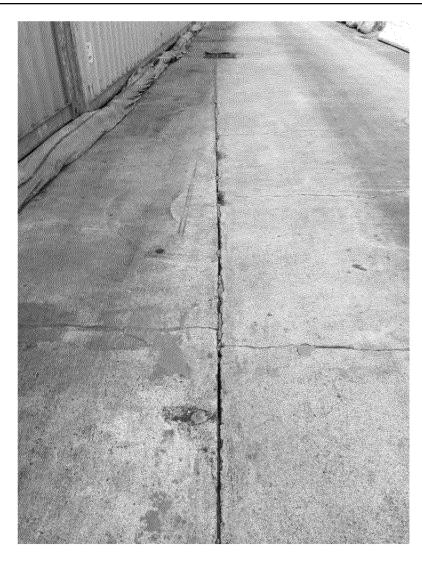
Photo 5 - Looking south toward drain inlet 3DI-11A: areas of surficial cracking and concrete seam.

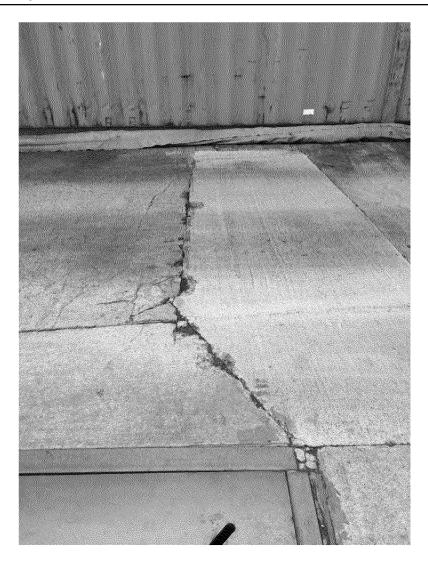
- **SW-4 Area** Areas of minor surficial cracks were observed along the rail line south of interceptor SW-4 (Appendix A; Photo 6). Sealant was noted extending from the southeast corner of interceptor SW-4 toward the east (Appendix A; Photo 7). Minor surficial cracks were observed north of interceptor SW-4 (Appendix A; Photo 8).

with sealant added in December 2013.

Photo 7 - Looking east from corner of interceptor SW-4: crack extending east Photo 8 - Looking southwest toward 4DI-19: surficial cracks. sealant added in December 2013.

Aspect	Description	Anticipated Completion Date
General	Implement all activities (i.e., cap maintenance, storm water monitoring, interceptor cleanout) described in the O&M Plan. ¹	Continuously
	Submit report of O&M performed for the period of July 1, 2015 to June 30, 2016.	On/around July 15, 2016
Concrete Cap	Perform 2015-2016 annual inspection of the cap under oversight of a registered engineer.	June 1, 2016
	Monitor deteriorated concrete in the southern portion of the eastern swale of the Main Terminal identified in Photos 17 and 18 (Appendix A); replace affected sections should evidence of underlying soil be observed.	Continuously
	Monitor identified cracks, seals, and joints for signs of propagation and/or degradation throughout upland capping system.	Continuously
Gravel Cover	Add gravel to the interceptor SW-4 and SW-5 areas identified in Photos 7 and 11 (Appendix A) to ensure proper coverage.	October 1, 2015

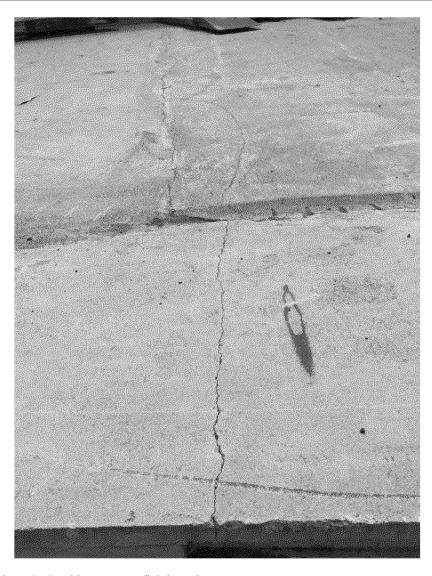
- SW-5 Area Minor cracks were noted north and south of interceptor SW-5 (Appendix A; Photos 9 and 11). Light gravel cover was observed to the north of interceptor SW-5 (Appendix A; Photo 10).

Photo 9 - Looking east: surficial cracks.

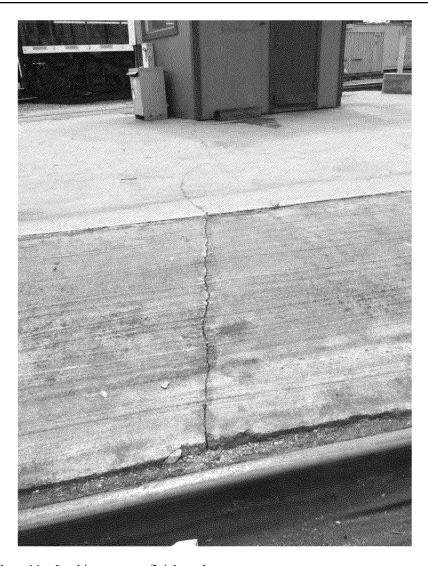
Photo 11 – Looking east: surficial cracks.

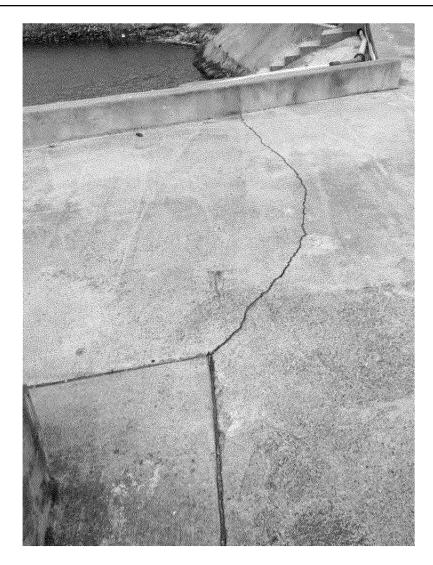
- **SW-6** Area Minor cracks were noted north and northeast of interceptor SW-6 (Appendix A; Photos 12 and 14). Seams and surficial cracks were observed in the eastern swale of the Main Terminal (Appendix A; Photos 15 and 16). Small areas of concrete deterioration were observed in the southern portion of the eastern swale of the Main Terminal (Appendix A; Photos 17 and 18).

Photo 12 – Looking west toward Municipal Outfall: seams and surficial cracks.

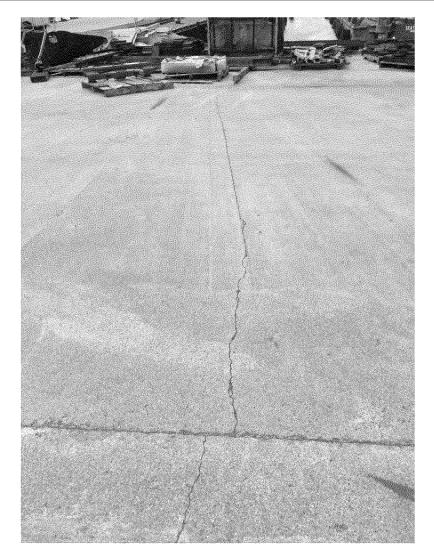
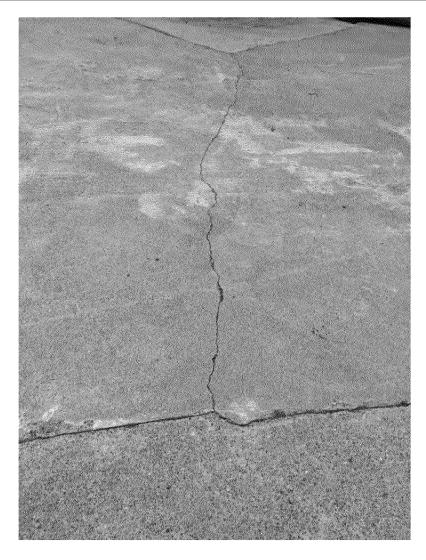
- **SW-7 Area** Minor cracks were observed to the northeast of interceptor SW-7 (Appendix A; Photo 13).

Photo 13 - Northwest corner of site, looking south near interceptor SW-7: minor Photo 14 - Northeast corner of site: minor surface cracks. surface cracks noted.

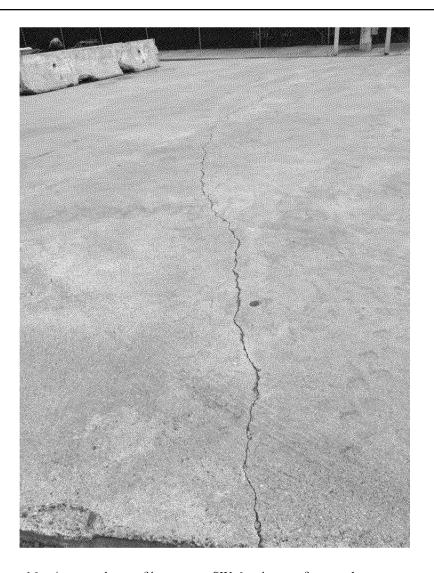
Photo 16 – Area southeast of interceptor SW-6: minor surface cracks.

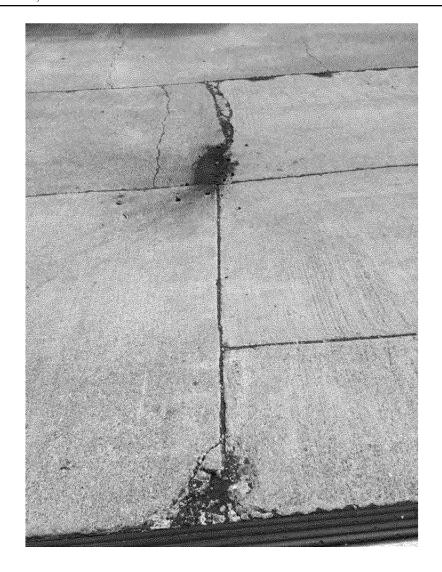
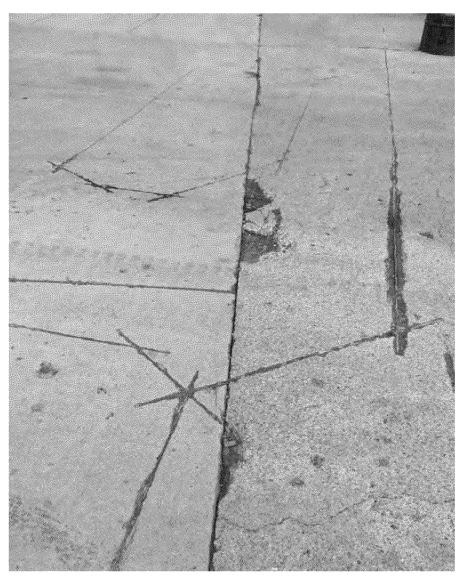
Photo 17 – Looking east, north of 5DI-14A: areas of minor concrete Photo 18 – Looking east, north of 5DI-14A: areas of minor concrete deterioration.

- Add gravel to gravel cover areas of SW-4 and SW-5;
- Monitor deteriorated concrete in the southern portion of the eastern swale of the Main Terminal at SW-6, and replace affected sections of concrete should further deterioration occur or evidence of underlying soil be observed;
- Implement BMPs identified in the LRT SWPPP (Weiss, 2015).
